DIRECTOR OF S & T ENGINEERING.
WEST MIDLANDS PROJECTS GROUP.

*THE CLAPHAM JUNCTION
RAILWAY ACCIDENT*

On the morning of Monday 12th, December 1988 a tragic accident occurred at Clapham Junction on the Southern Region that resulted in a formal Investigation headed by Anthony Hidden QC. The findings of these investigations were presented to Parliament by the Secretary of State for Transport in November 1989.

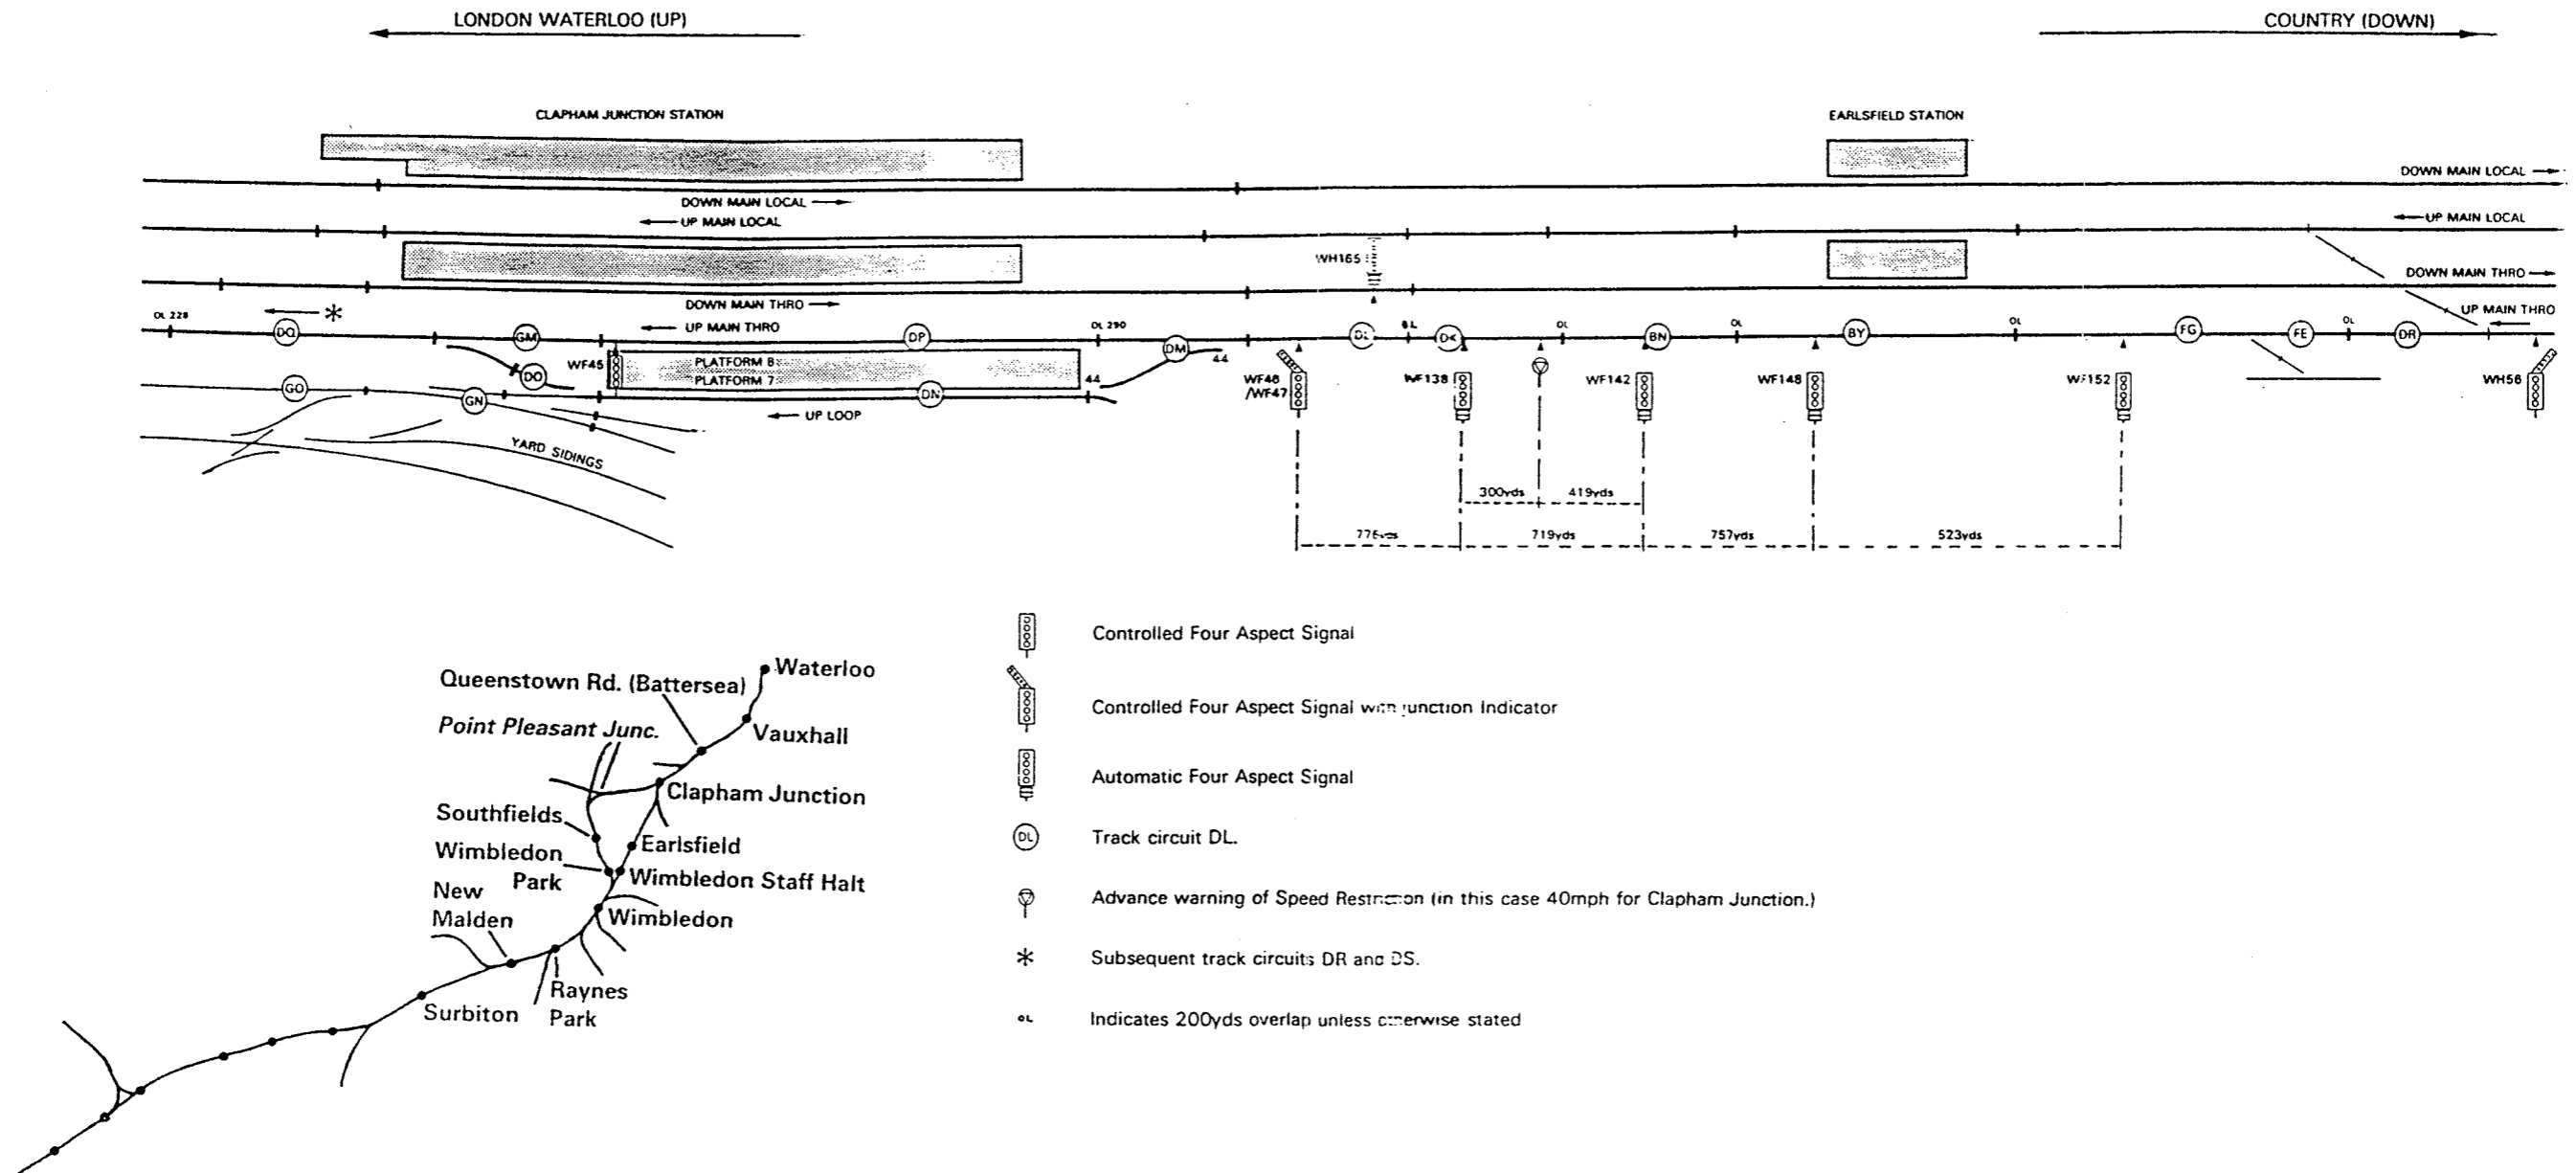
FIGURE 1.

The site of the accident was between signals WF46/47 a controlled signal and WF 138 an automatic signal, see Fig 1. At the time of impact the Basingstoke train was stationary at signal WF 46/47 and the Haselmere train was passing the site of the accident in the opposite direction.

Relevant Sections of Signalling System and Track Circuits Around the Accident Scene

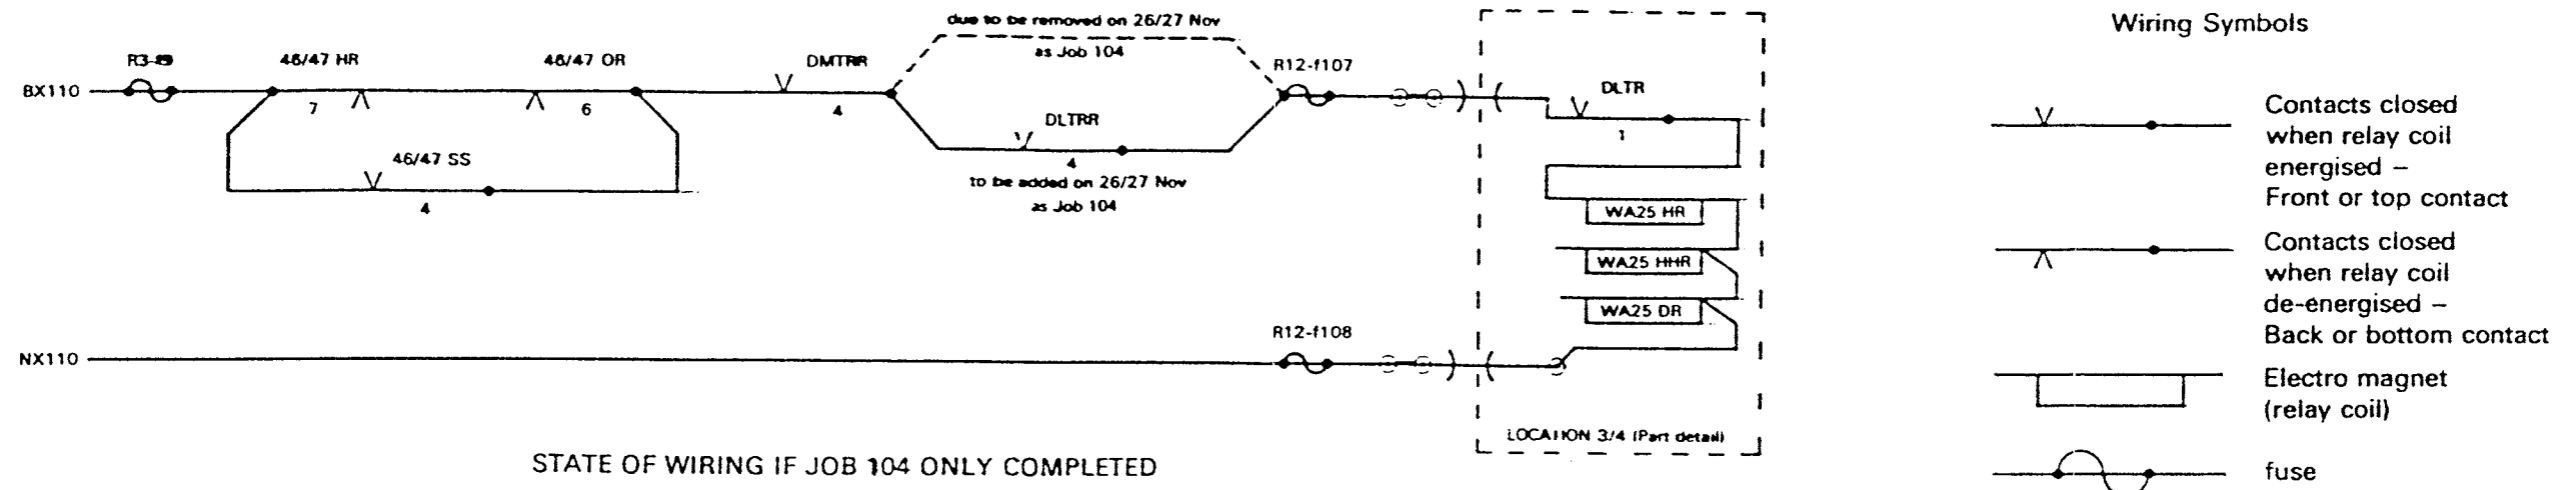
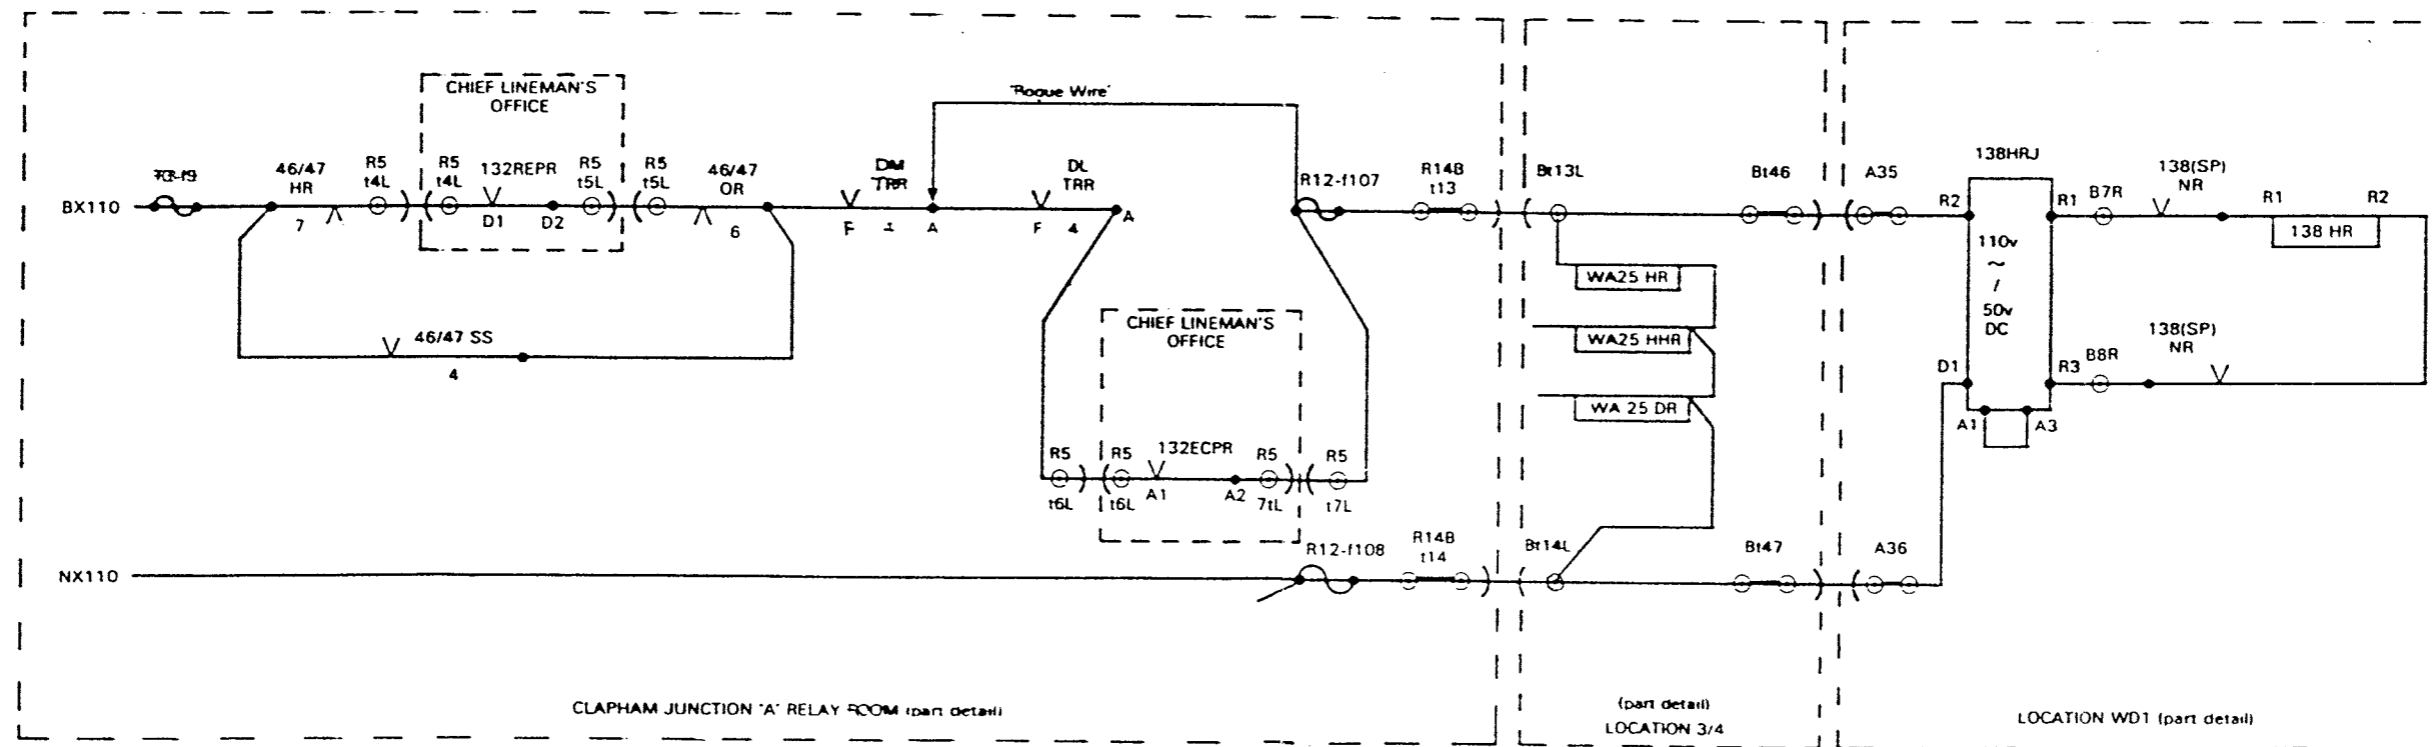
FIGURE 2.

On the weekend of 26th/27th November 1988 two wiring alterations were completed at Clapham "A" Relay Room, Job No's 104 & 201 see Fig's 2 & 3. During the course of the installation work on this weekend a wire should have been recovered between DM TRR.4A and fuse R12-f107 which had the effect of introducing Track Circuit "DL" into the HR circuit of WF 138 Signal. For some reason only the wire on DM TRR.4A had been disconnected and "bent back", the fuse end remaining connected (remember in this type of installation removing the wire would have been virtually impossible as the wires are all tied into "trees" between the relay racks). The cut wire was not taped and cut back to the wiring tree as per usual practice.

Two weeks later on Sunday 11th December 1988 a relay was changed "DN TR", this relay happened to be situated adjacent to relay "DM TRR". During the changing of this relay the wires were disturbed and the wire that was originally terminated on DM TRR.4A moved back to the position it had been terminated on prior to disconnection on the weekend of 26/27th November. The effect this had on WF 138 HR was to "strap out" the "DL TRR" control in the circuit thus any train standing on DL Track Circuit would remain undetected to the control relay. Therefore the Basingstoke train when standing at WF 46/47 Signal with the signal showing at least "single yellow" would have meant that Signal WF 138 would be showing at least "double yellow" to Driver Rolls who was approaching this signal in the Poole train.

Control Circuits for Signal WF 138

1. BR shall ensure that there is rigorous implementation of the practice of cutting back redundant wires, insulating, and securing them, so that there is no risk of wires coming into contact with working circuitry. Cutting back must be done before commissioning.
2. BR at national level shall be responsible for updating and creating new standards of installation.
3. BR shall enforce tighter control on Design Office procedures for the production, issue and amendment of documents to ensure that all working drawings are complete and are an accurate representation of the system to be worked on and of the work to be done to that system.

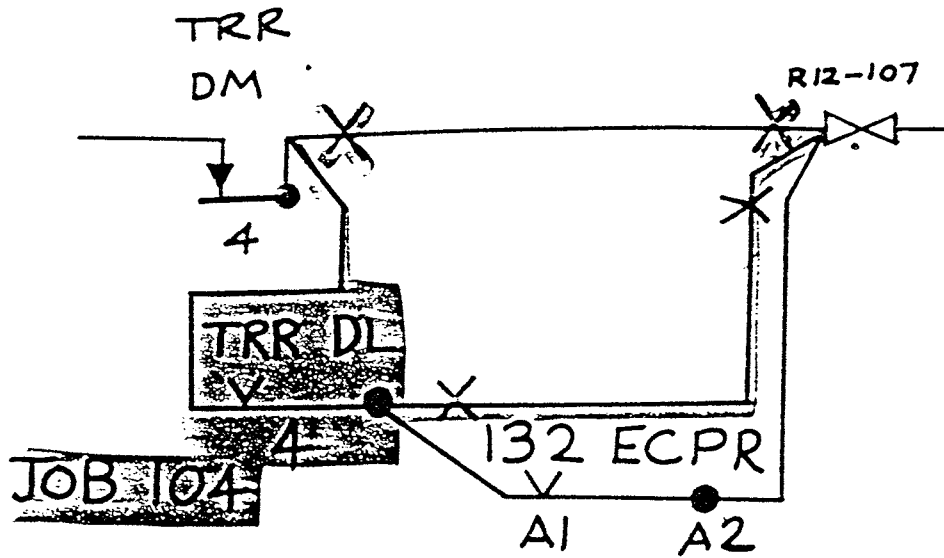
FIGURE 3. Diag JOB 201

Extract from Design Office working diagrams for JOB No's 104 & 201.

Installation Staff and Testing Staff were issued with these diagrams to work to.

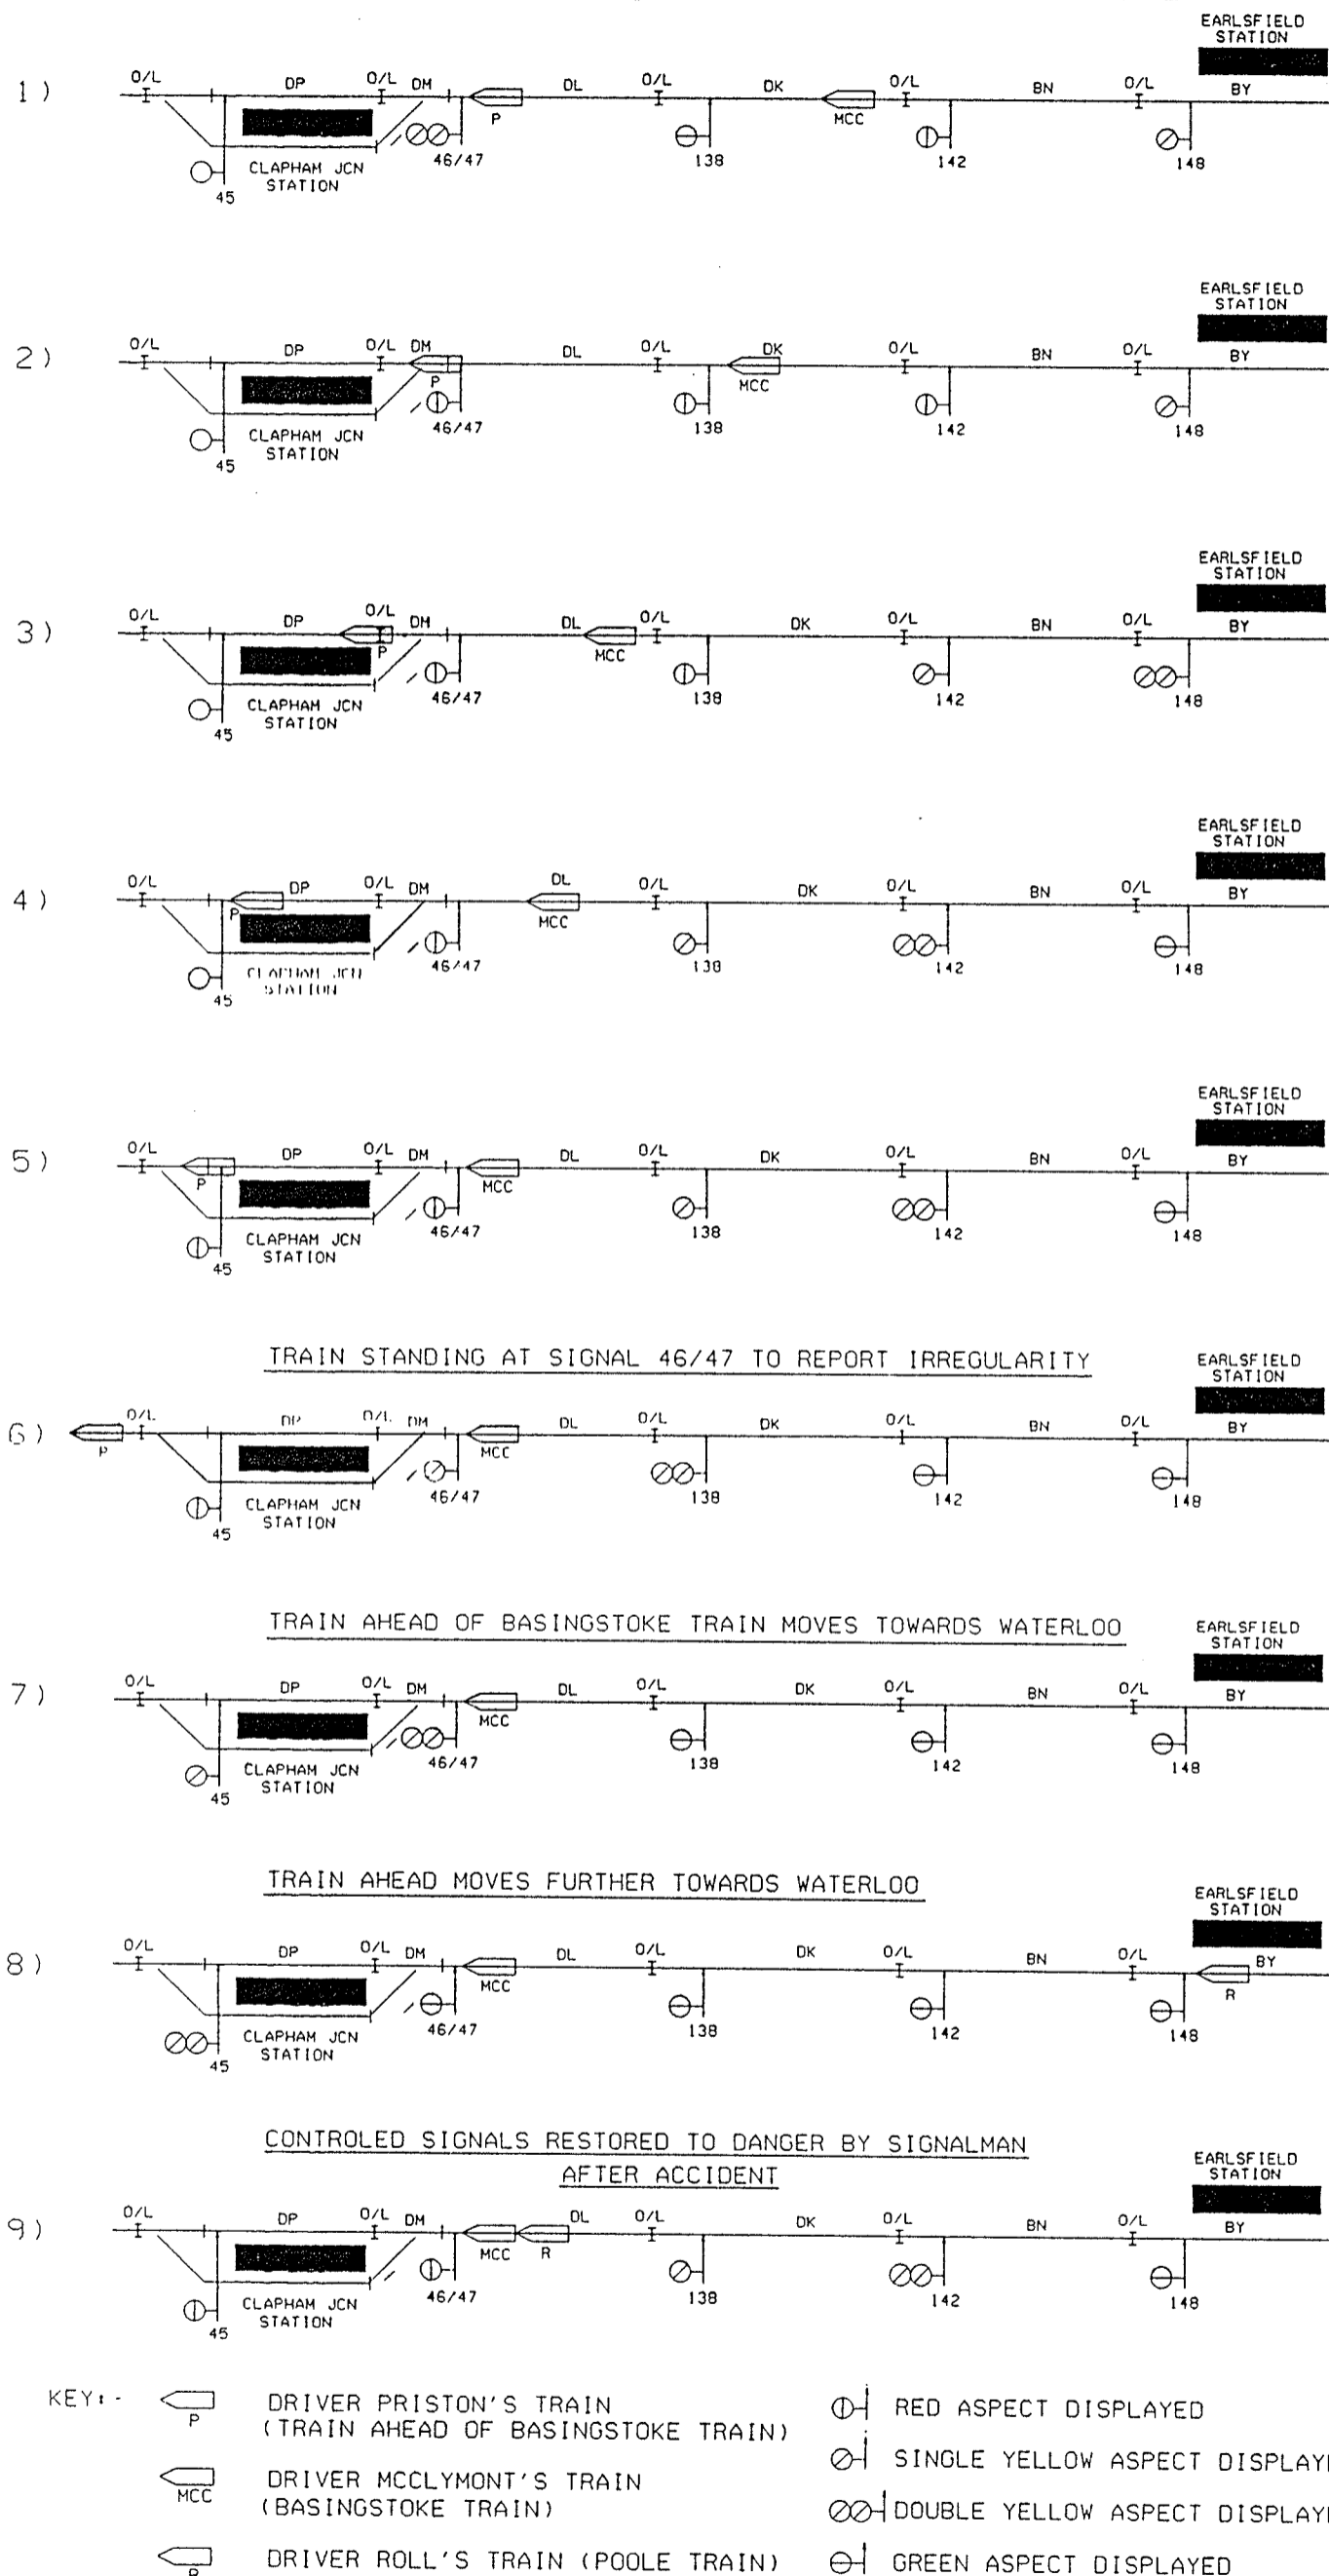
FIGURE 4.

This aspect sequence had gone undetected to the previous trains running over the line but as the frequency of traffic increased the Headway time reduced (trains travelling closer together) and Driver McClymont noticed the "Green—>Red" aspect on WF 138 because he was closely following another train. In fact the train in question ahead of the Basingstoke train was just passing Signal WF 46/47.

If you consider the sketches on Figure 4 you can appreciate how the driver of the Basingstoke train saw a "Green—>Red" aspect on WF138 Signal.

ASPECT SEQUENCE OF SIGNALS IMMEDIATELY BEFORE & AFTER THE ACCIDENT
