DIRECTOR OF S & T ENGINEERING.
WEST MIDLANDS PROJECTS GROUP.

*THE CLAPHAM JUNCTION
RAILWAY ACCIDENT*

On the morning of Monday 12th, December 1988 a tragic accident occurred at Clapham Junction on the Southern Region that resulted in a formal Investigation headed by Anthony Hidden QC. The findings of these investigations were presented to Parliament by the Secretary of State for Transport in November 1989.

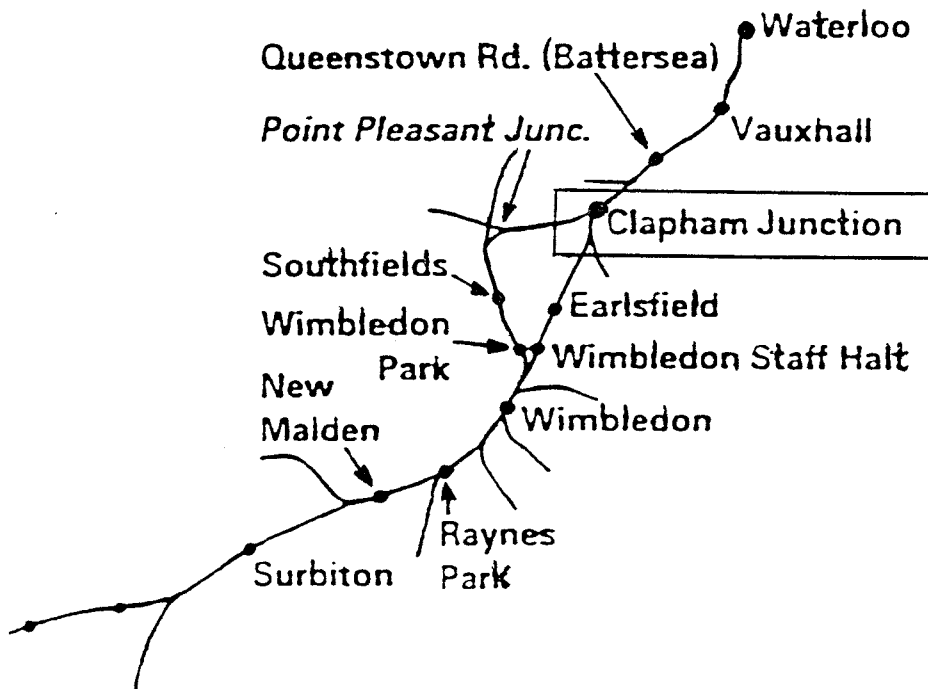
At 08.10 on Monday 12th, December 1988 a crowded commuter train (the Poole train) ran into the rear of another train (the Basingstoke train) in a cutting just south of Clapham Junction station. After that collision the Poole train veered to the right and struck a third oncoming train (the Haselmere train).

As a result of the accident 35 people died and nearly 500 were injured, 69 of them seriously.
